Homeowner’s Guide

The Life Cycle of Your Roof

What to Expect From Your CertainTeed Roof

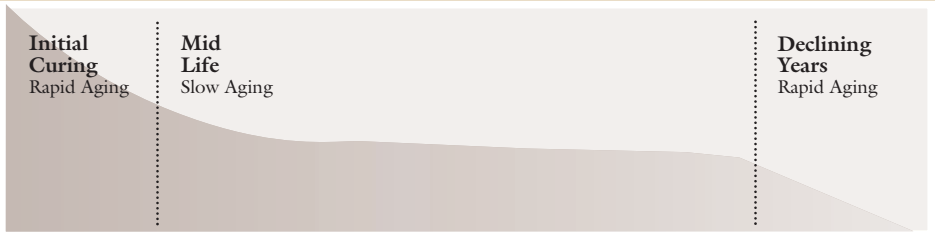
The Life Cycle of a Roofing Shingle

When your new roof was installed, friends and neighbors may have remarked how it enhanced the beauty of your home. However, research indicates that aging begins soon after the shingles are installed and progresses rapidly during the initial curing phase of its life cycle. During this stage, granule loss may occur, small blisters may develop, or the shingles may curl slightly at their edges. You may even notice that this curling is more pronounced during cold weather and the shingles may lie flat as temperatures rise. The good news, however, is that after this curing stage the shingles enter a long period of slow aging, which lasts for the major portion of the shingle’s natural life.

During the “mid-life” period, aging continues at a much slower rate. The cracking or granule loss still occurs but does not increase at a noticeable rate. Only after this long period of mid-life does the aging process begin to accelerate once again as the shingles enter their declining years. It’s during this period that homeowners normally think about replacing their roofs.
